THE UNITED STATES  
STRATEGIC BOMBING SURVEY

# THE ELECTRIC POWER INDUSTRY OF JAPAN

(Plant Reports)

Electric Power Division

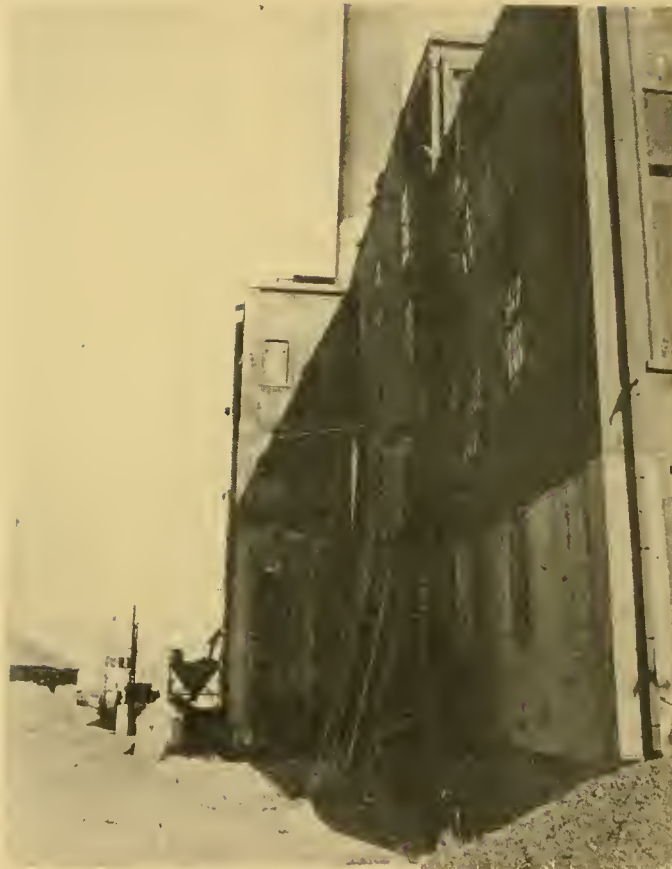
Photo 1—SAKA STEAM ELECTRIC STATION

End wall on NE end of section 2, station 1 (25,000 KW extension) showing blast from atomic bomb in Hiroshima, 2 and  $\frac{3}{4}$  miles away.

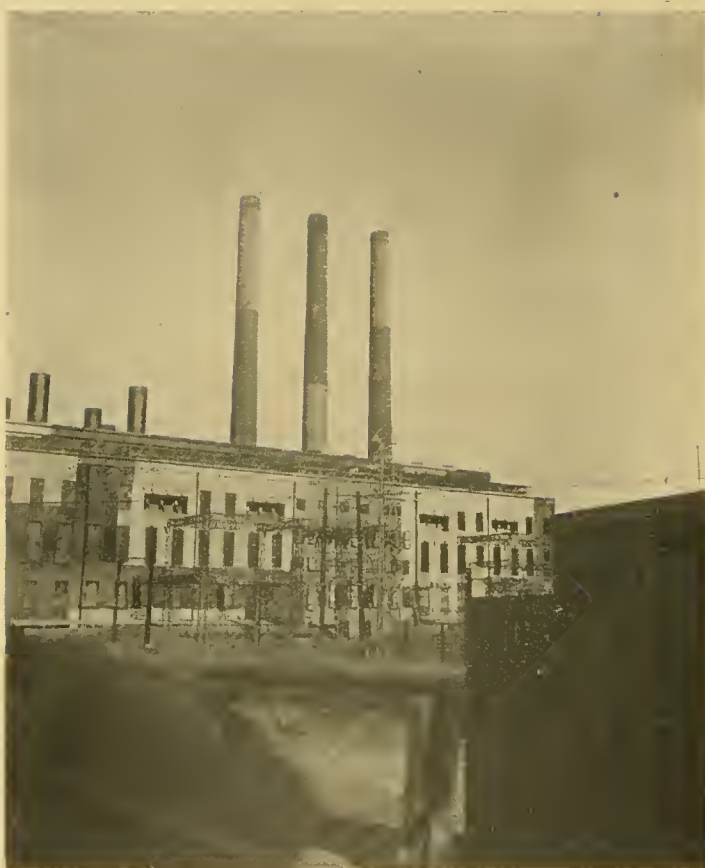
Photo 3—SAKA STEAM ELECTRIC STATION

Station No. 1, looking from south switchyard side, showing stacks of sections I and 2.

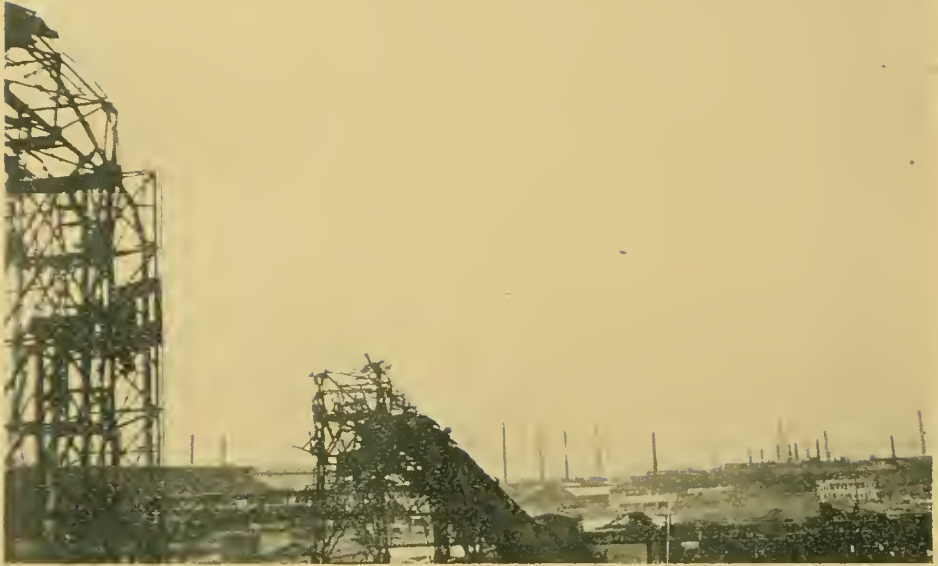
Photo 3—Direct hit on north coal conveyors looking north.

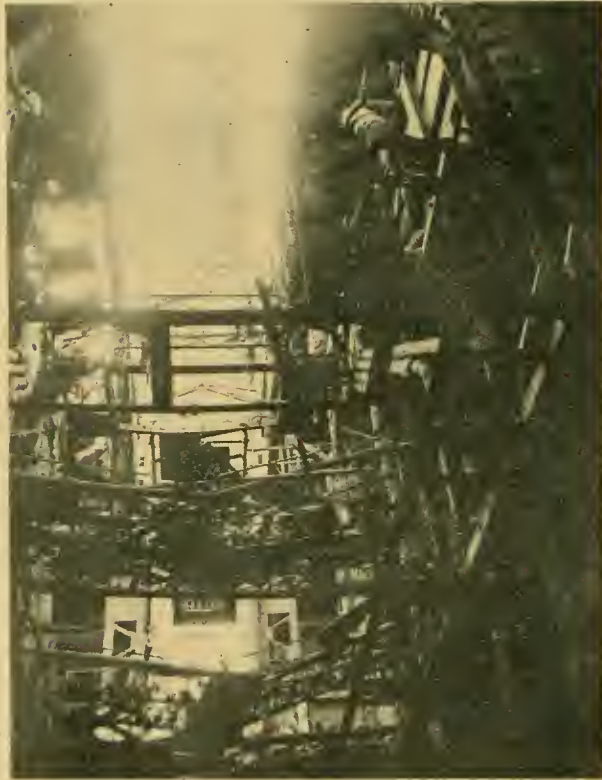
Photo 4—Looking up between boilers No. 1 and No. 2, showing damage to boilers, light iron, sky light support and bomb hit on stack No. 1.

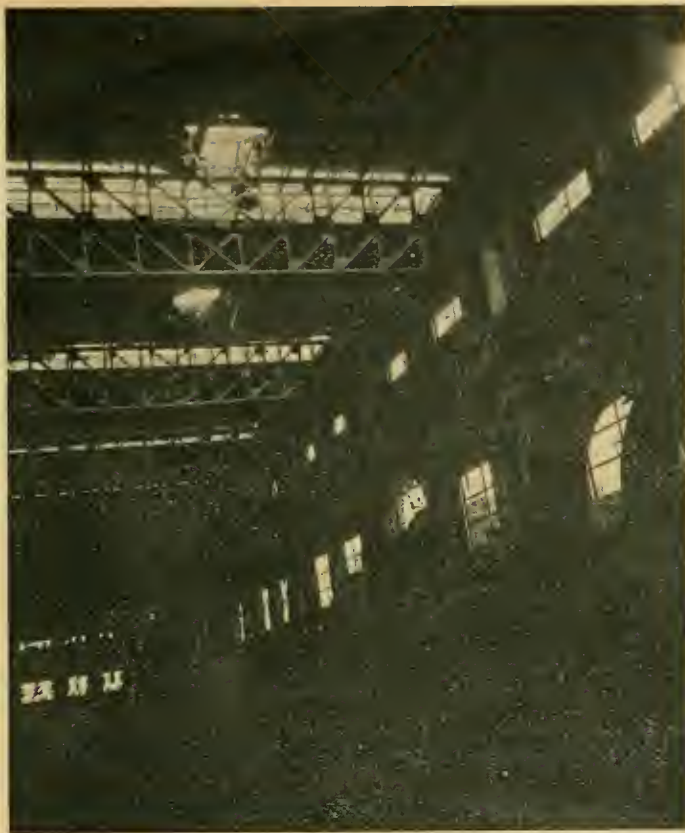
Photo 5—Two bomb hits on ceiling of turbogenerator room.

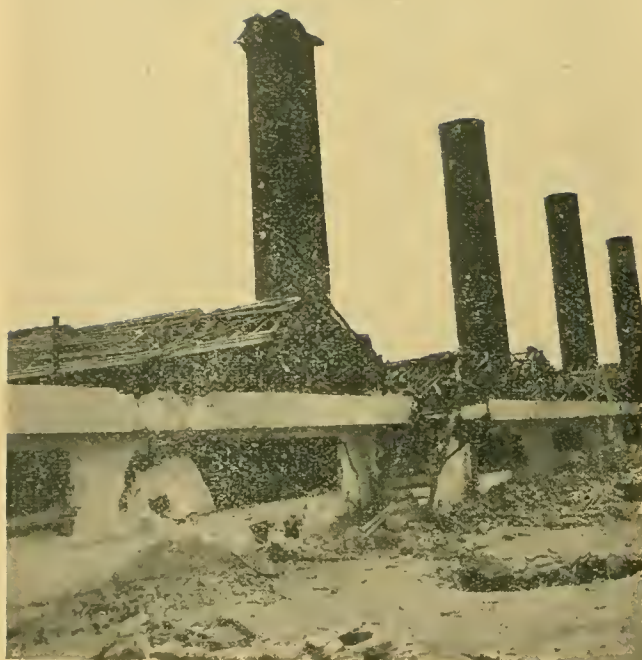
Photo 5—View looking south of damaged boiler house roof

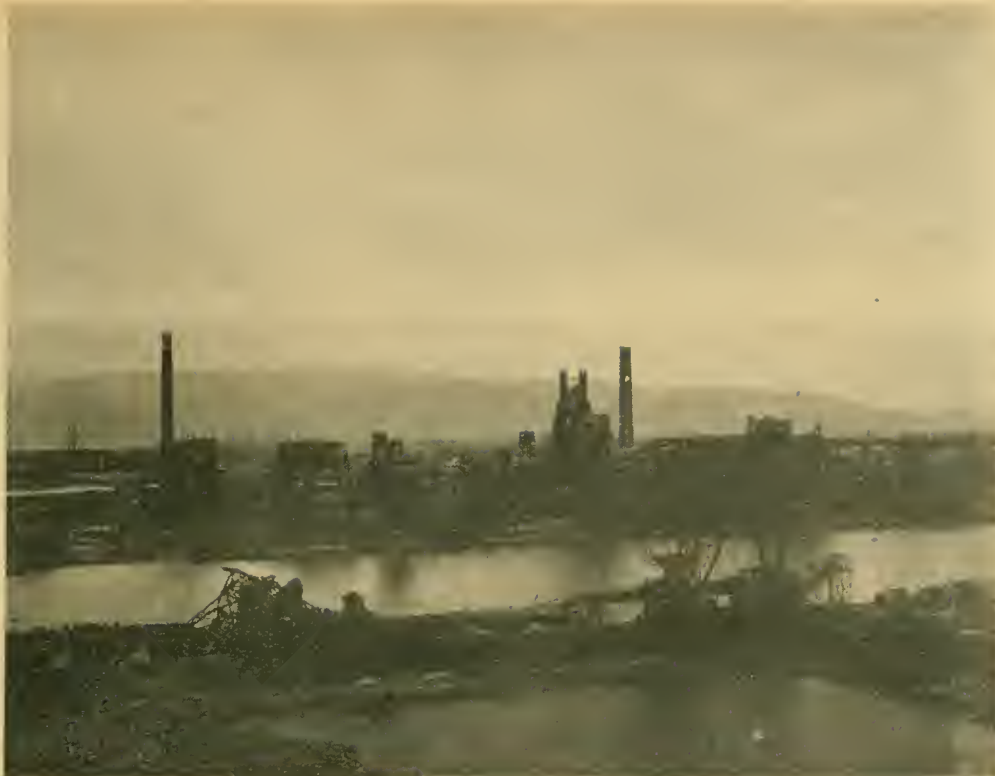
Photo 7—View looking north from top of boiler house showing damaged coal handling equipment with Nippon Oil Refinery across canal.

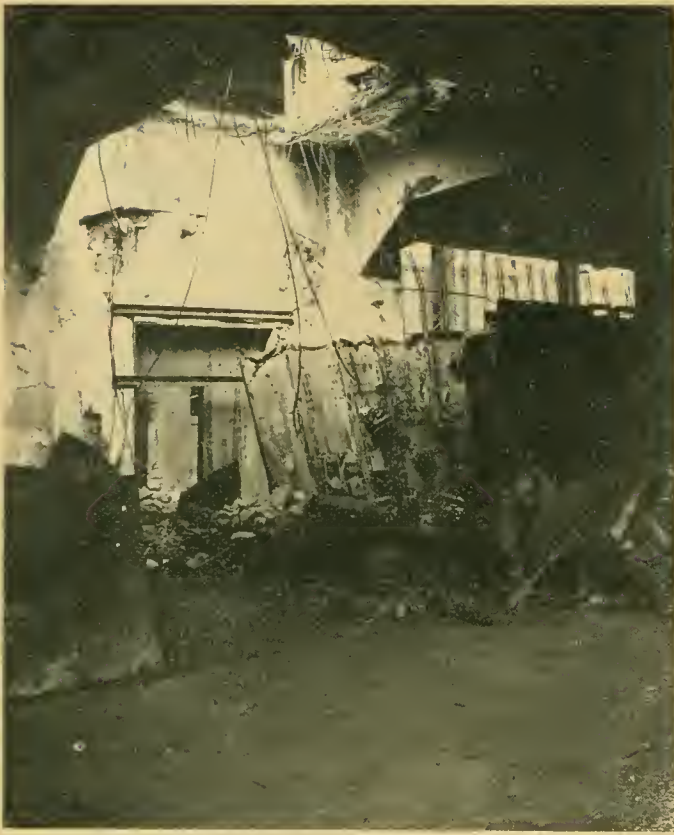
Photo 9—View of bomb hit in  
main control room

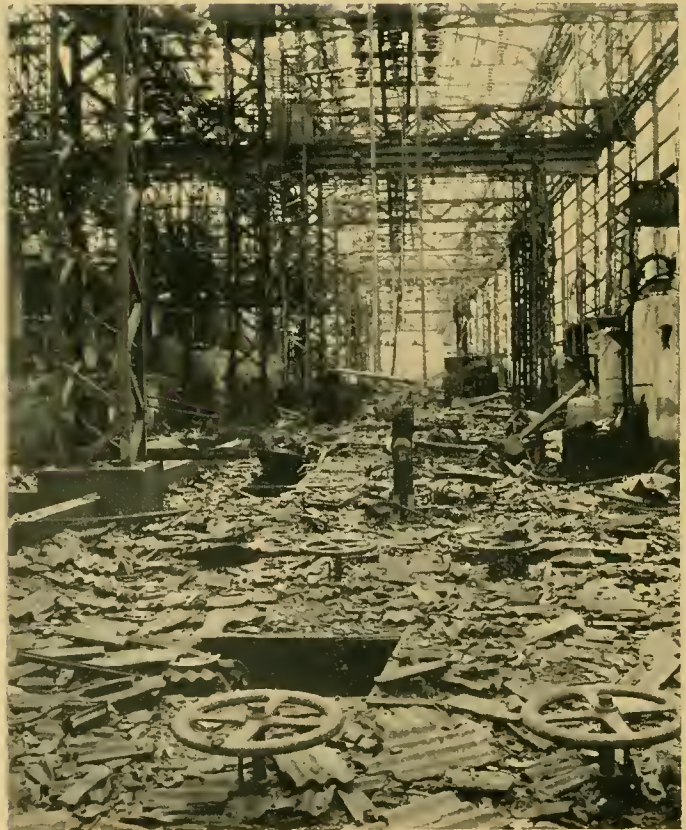
A large number of bombs struck the switching and transformer house. All transformers, and most of the oil circuit breakers, disconnecting switches, bus supports, coolers, pumps, control panels, and control cables were destroyed or very severely damaged directly or by the resulting fire. Exhibit C, photo 10 shows a general view of the switching and transformer house. Photo 11 shows a direct hit on an oil circuit breaker with fragmentation damage to others. Photo 12 shows where a bomb detonated near the base of a transformer bank destroying the center transformer and severely damaging an adjacent one on the left. Photo 13 shows the 3 oil coolers for one bank of transformers that has been damaged mostly by fire. In Exhibit C, photo 1 can be seen the damaged tower where transmission lines leave the plant. This photo, as well as Photos No 2 and 3, shows the wide spread destruction that existed throughout the plant.

Photo 10—General view inside transformer and  
switching building

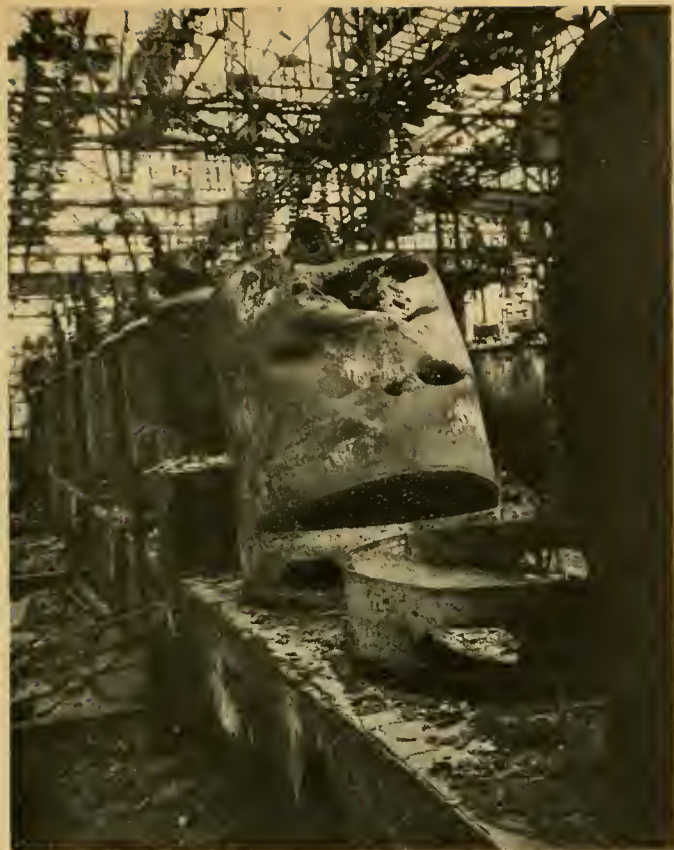
Photo 11—View of damaged oil circuit breaker

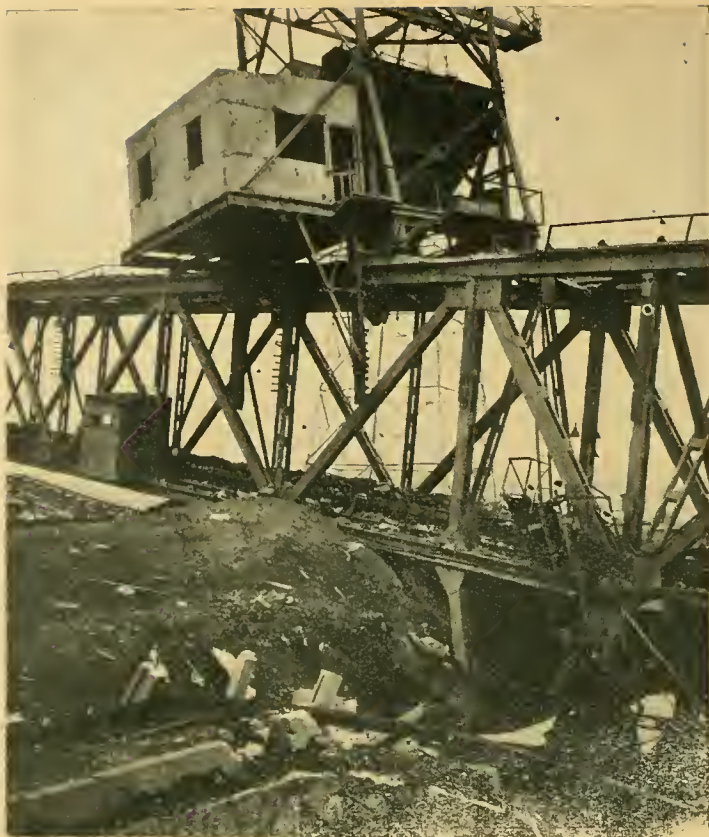
Photo 3—View of damage to traveling gantry crane in coal yard

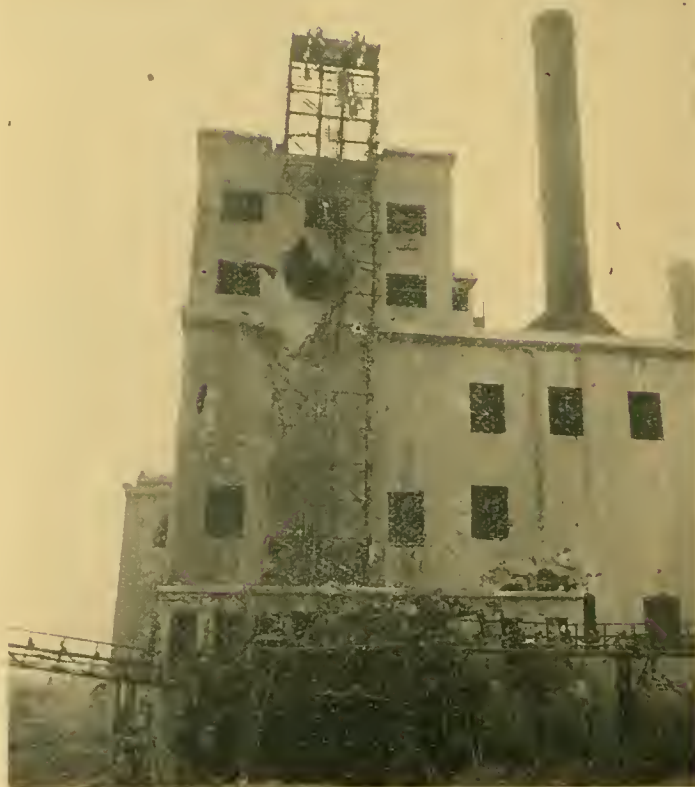
Photo 4—View showing damaged skiphoist and coal conveyor

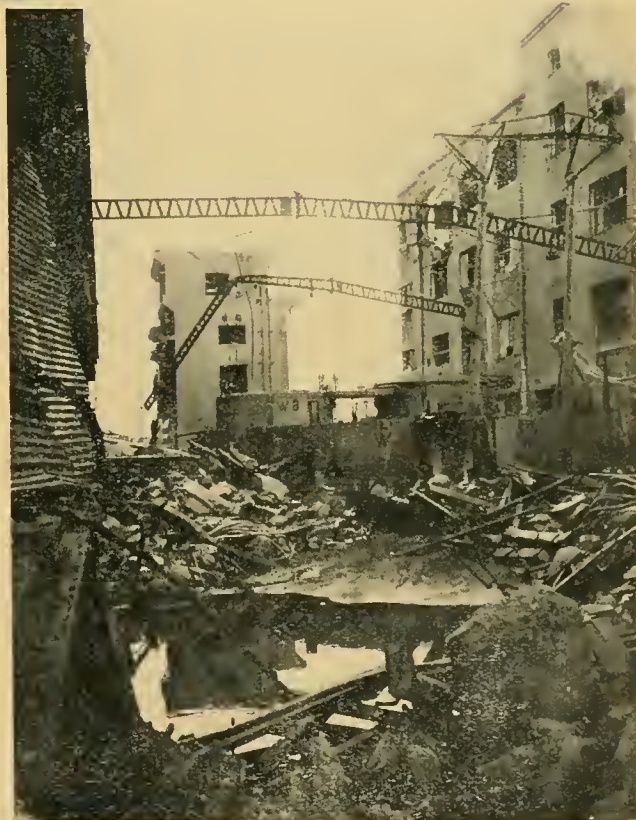
Photo 6—View showing bomb hit in space between turbogenerator bay and transformer house

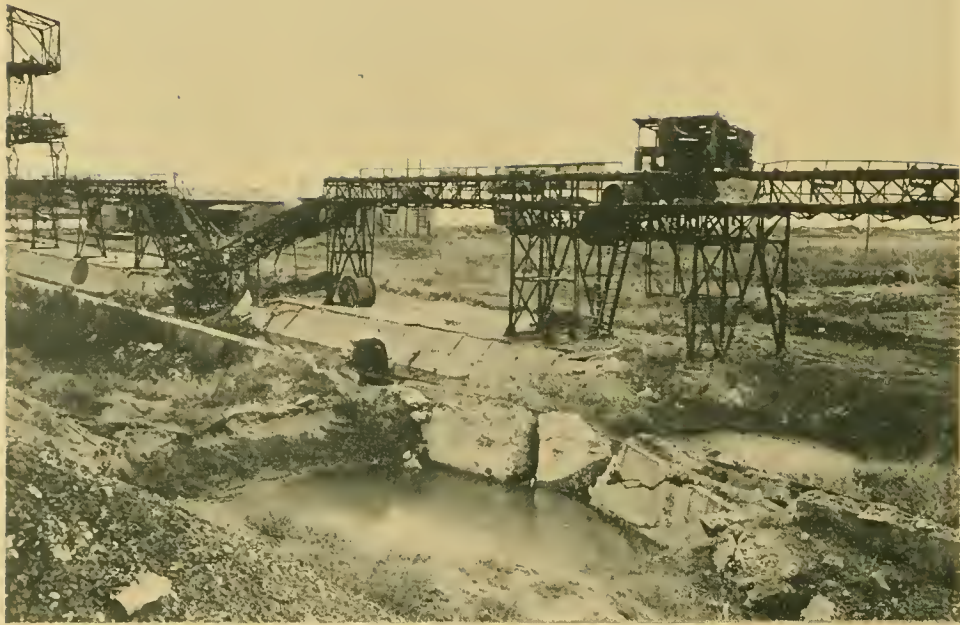
Photo 3—Damaged coal conveyors and crane

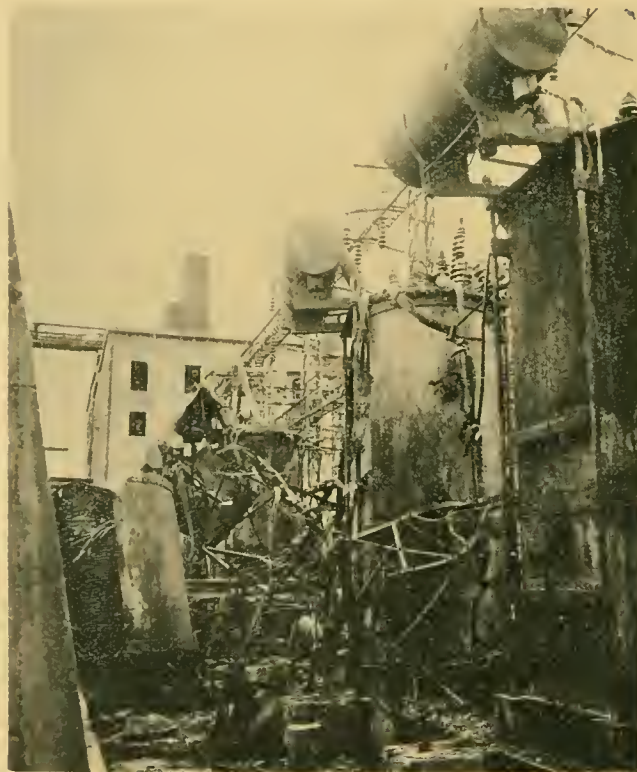
Photo 4—Main transformer bank showing transformer  
ruined by direct hit and adjoining ones ruined by oil fire—  
Raid number 1

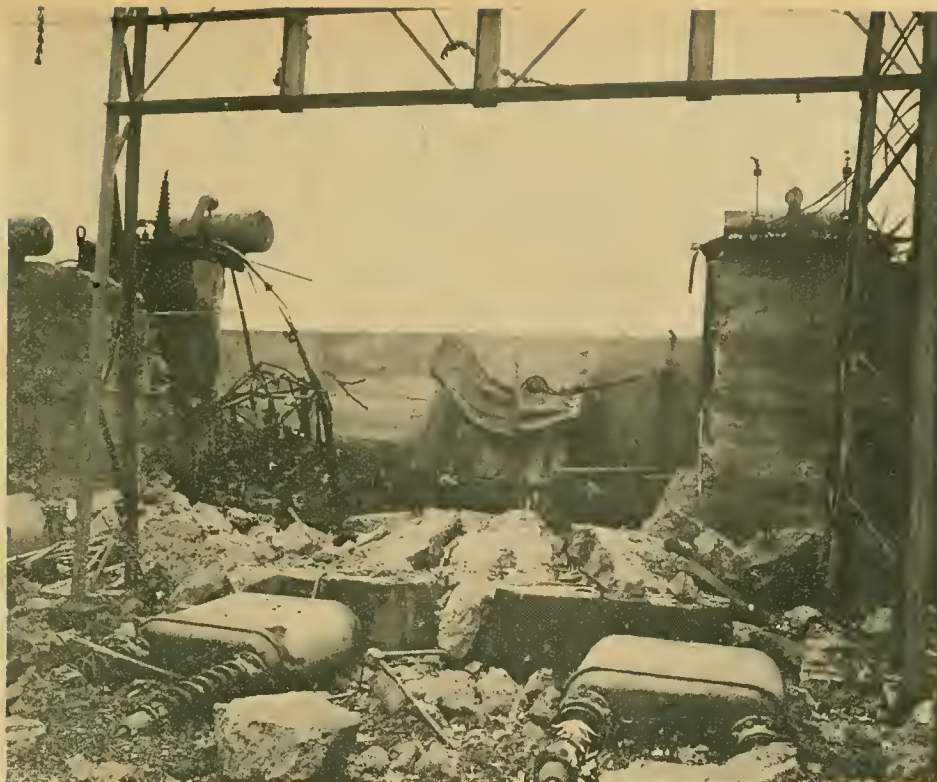
Photo 5—Rear view main transformer bank—note protective wall—Raid number 1

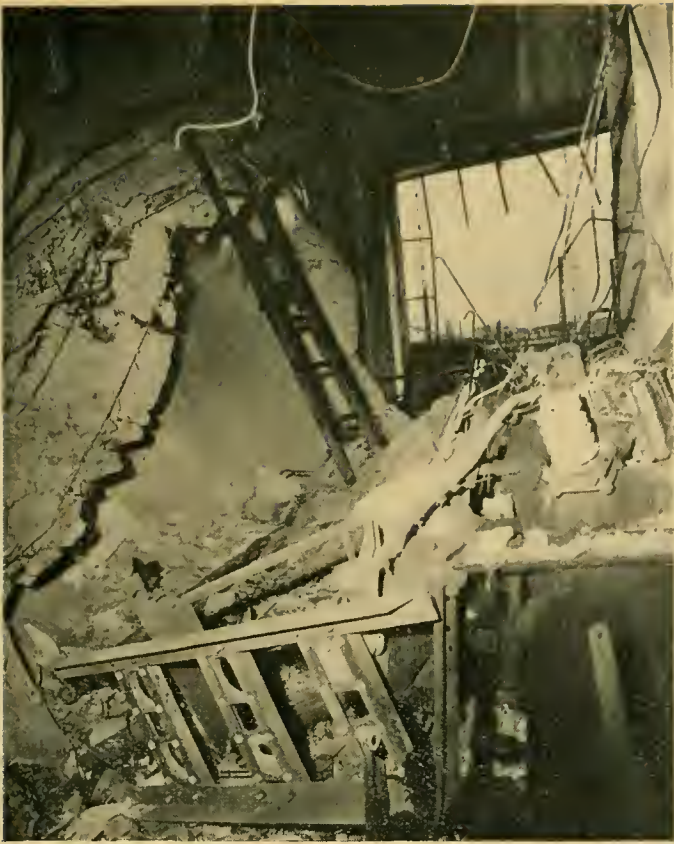
Photo 1—Close up view of damaged buss-run

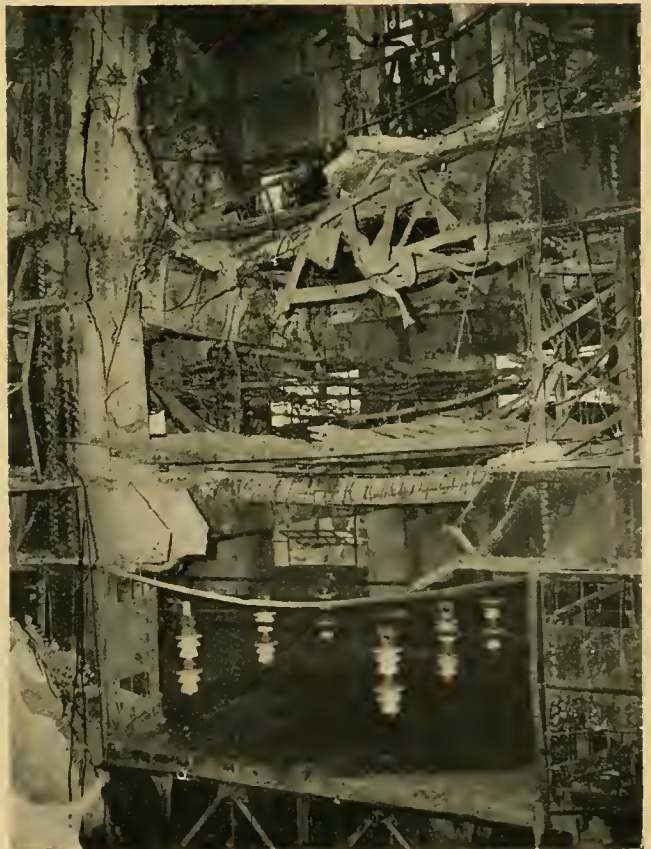
Photo 2—General view showing damage to  
busses and cables

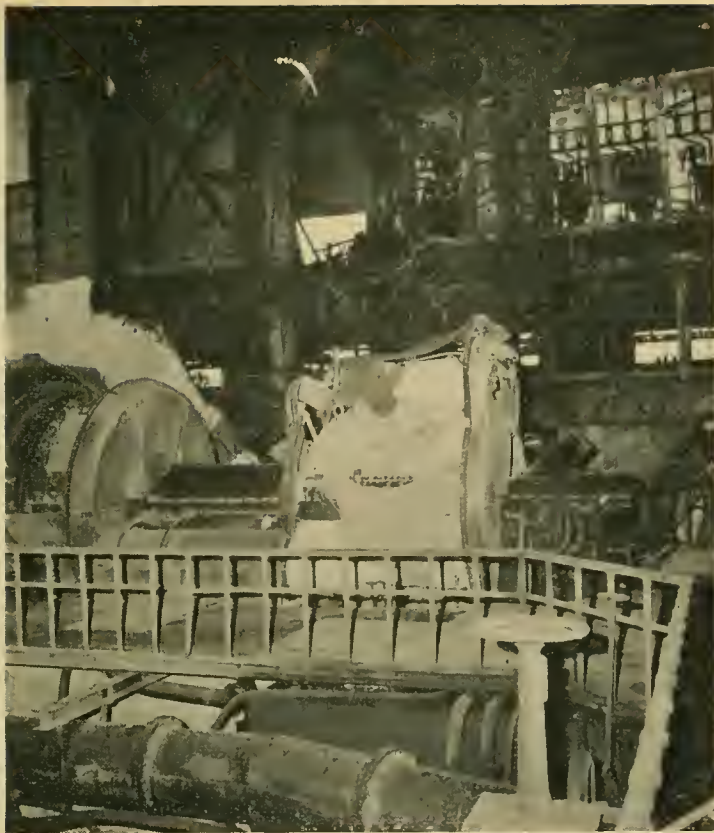
Photo 5—General view of blast effect in switch room and of number 2 steam turbine

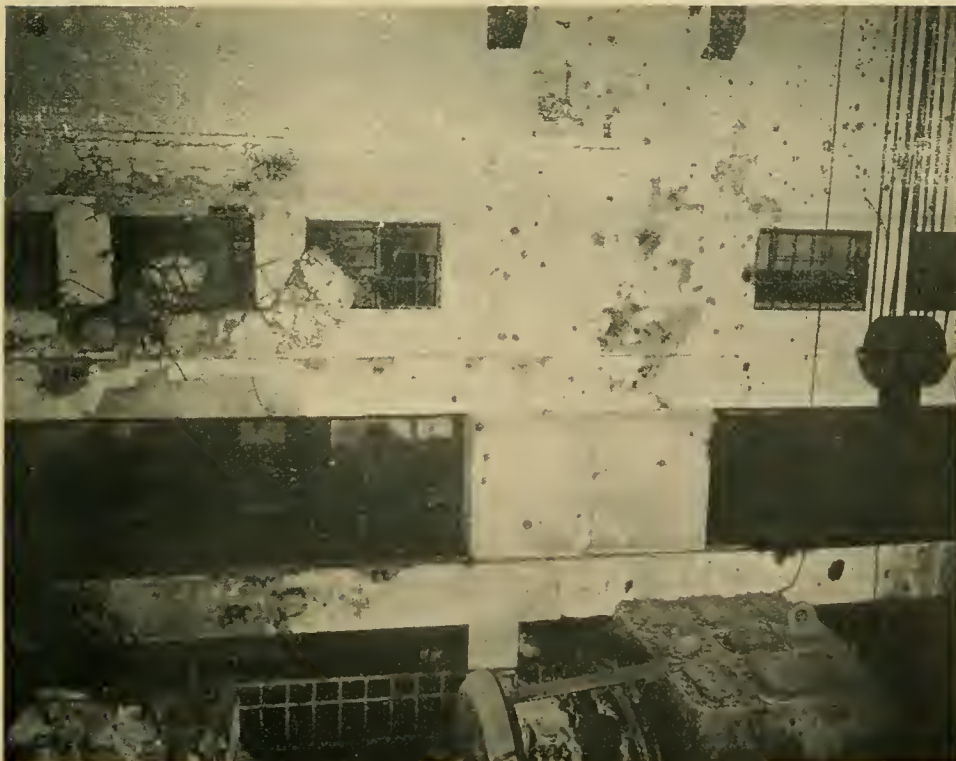
Photo 6—Fragmentation effect in interior of generator hall

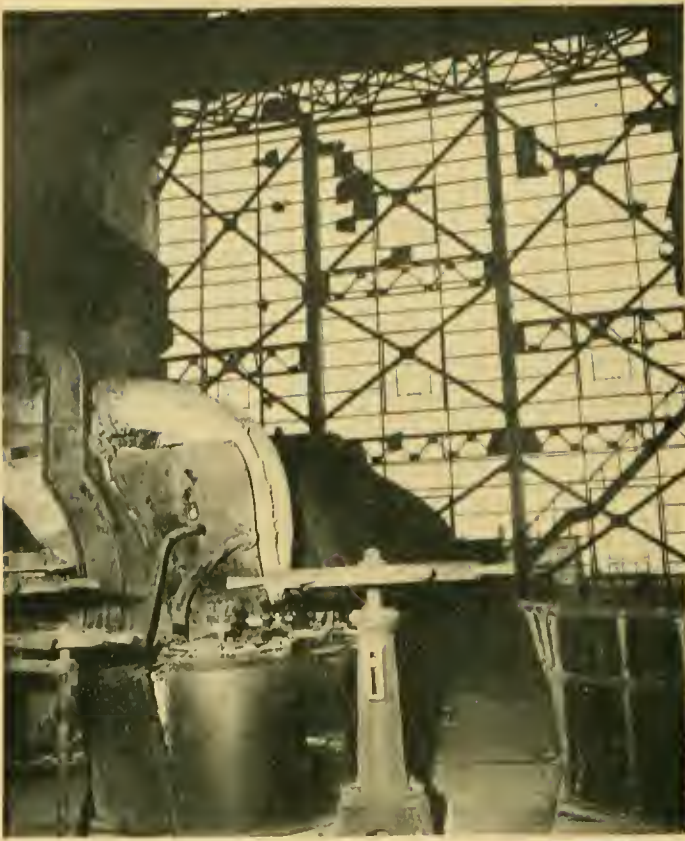
Photo 7—Fragmentation effect in interior of generator hall

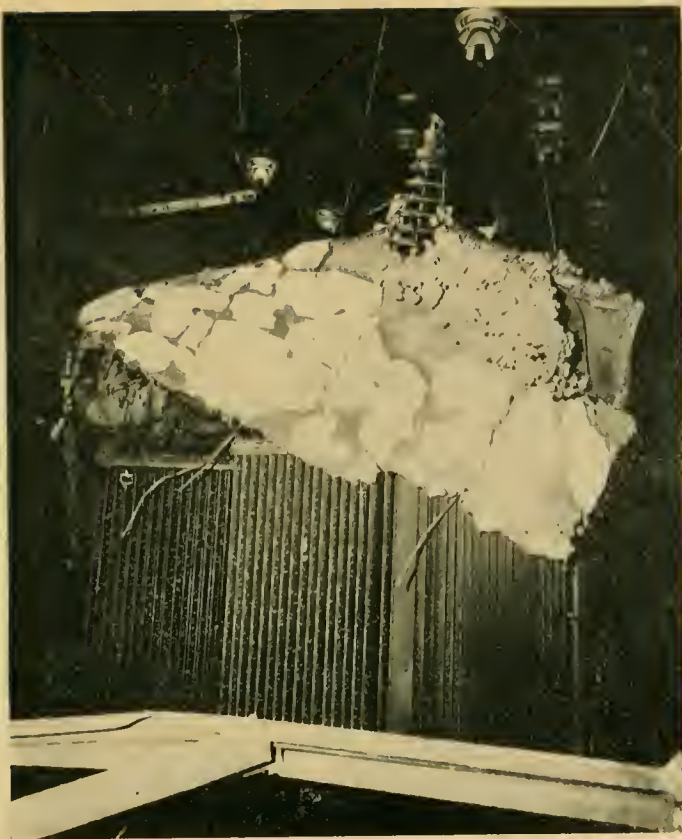
Photo 9—Damaged 43,750-KVA 3-phase transformer

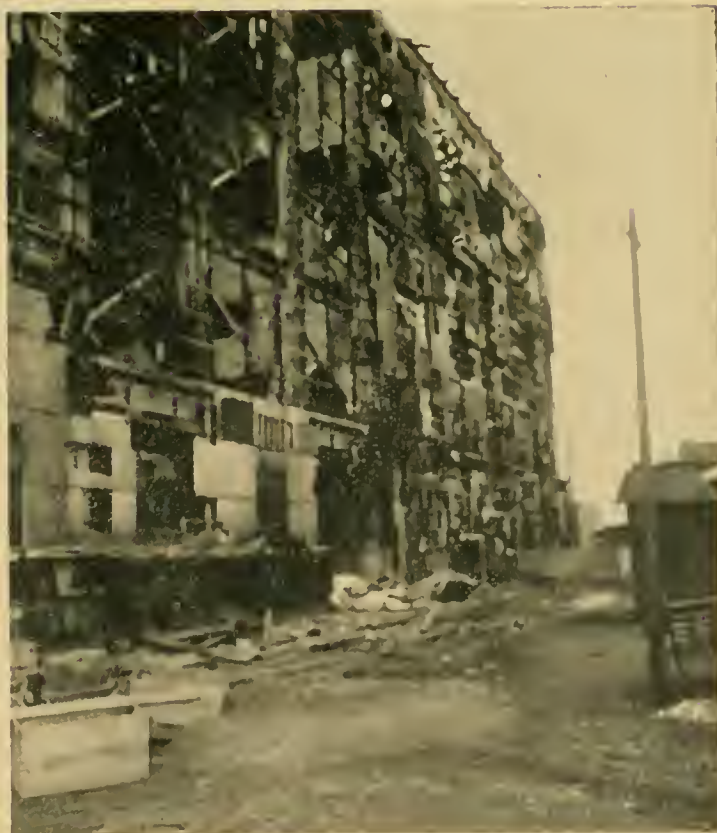
Photo 10—Damaged exterior of building

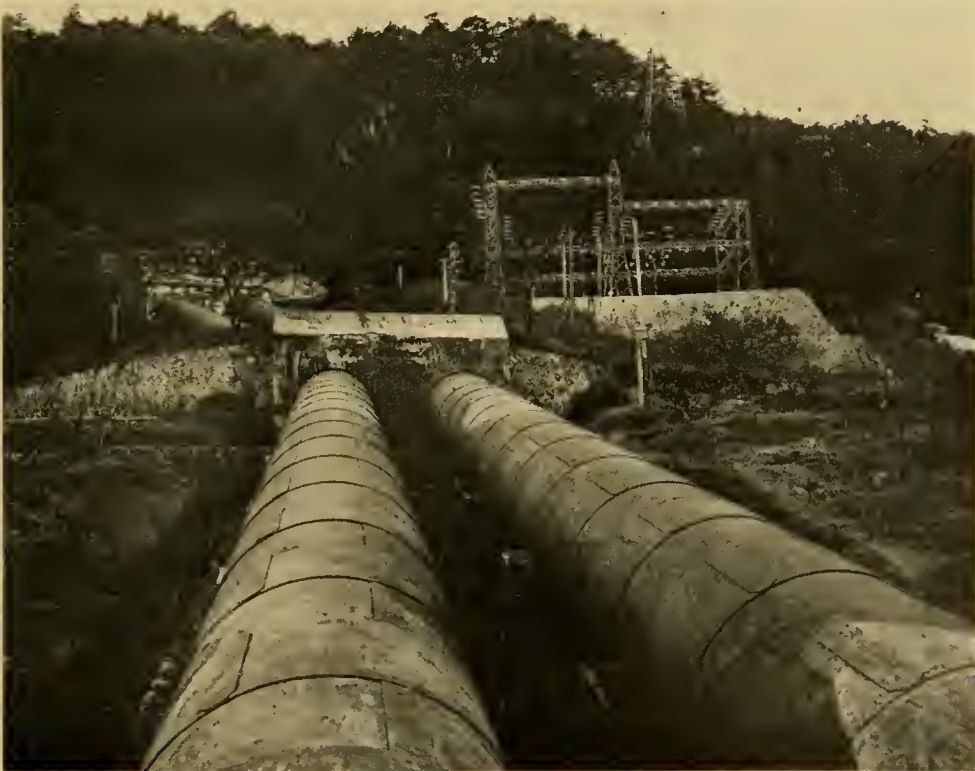
The Momoyama plant was completed in November 1923. (Exhibit C, photos 10 and 11). Water from the Kiso is diverted by a concrete diversion dam through a tunnel 1,400 ft in length to a head tank and there by 2 penstocks (Exhibit C, photo 12), each approximately 660 ft long, to the plant. No appreciable water storage is effected by the dam. The effective head is 260 ft, and the water quantity used is 1,300 cu ft/sec. There are 2 Escher Wyss, single-wheel, vertical-shaft turbines with Westinghouse generators, each rated 15,000-KVA at 80 percent PF, and double frequency of 50/or 60-cycles. The total name plate capacity is 24,000 KW, but the plant is rated at 24,600 KW. The main transformer and switching station is located outdoors (Exhibit C, photo 13); the transformers are adjacent to the station, and the switch yard is a short distance away at a higher elevation. There are six 5,000-KVA, 6.6/77 KV, single-phase, oil-immersed, water-cooled transformers and one spare, and the energy is supplied to the 77-KV, Okuwa, transmission line to the Rokugo substation at Nagoya. This station formerly had rotary frequency converter equipment in order that 60-cycle current generated in the hydro plants further down the Kiso River could be changed to 50-cycle in order to supply energy to the 50-cycle section of Japan. This was removed in October 1944 in order to reinstall it in Kyushu where it was greatly needed. According to information received but not verified, the installation in Kyushu has never been completed.

Photo 12—Momoyama power plant penstocks

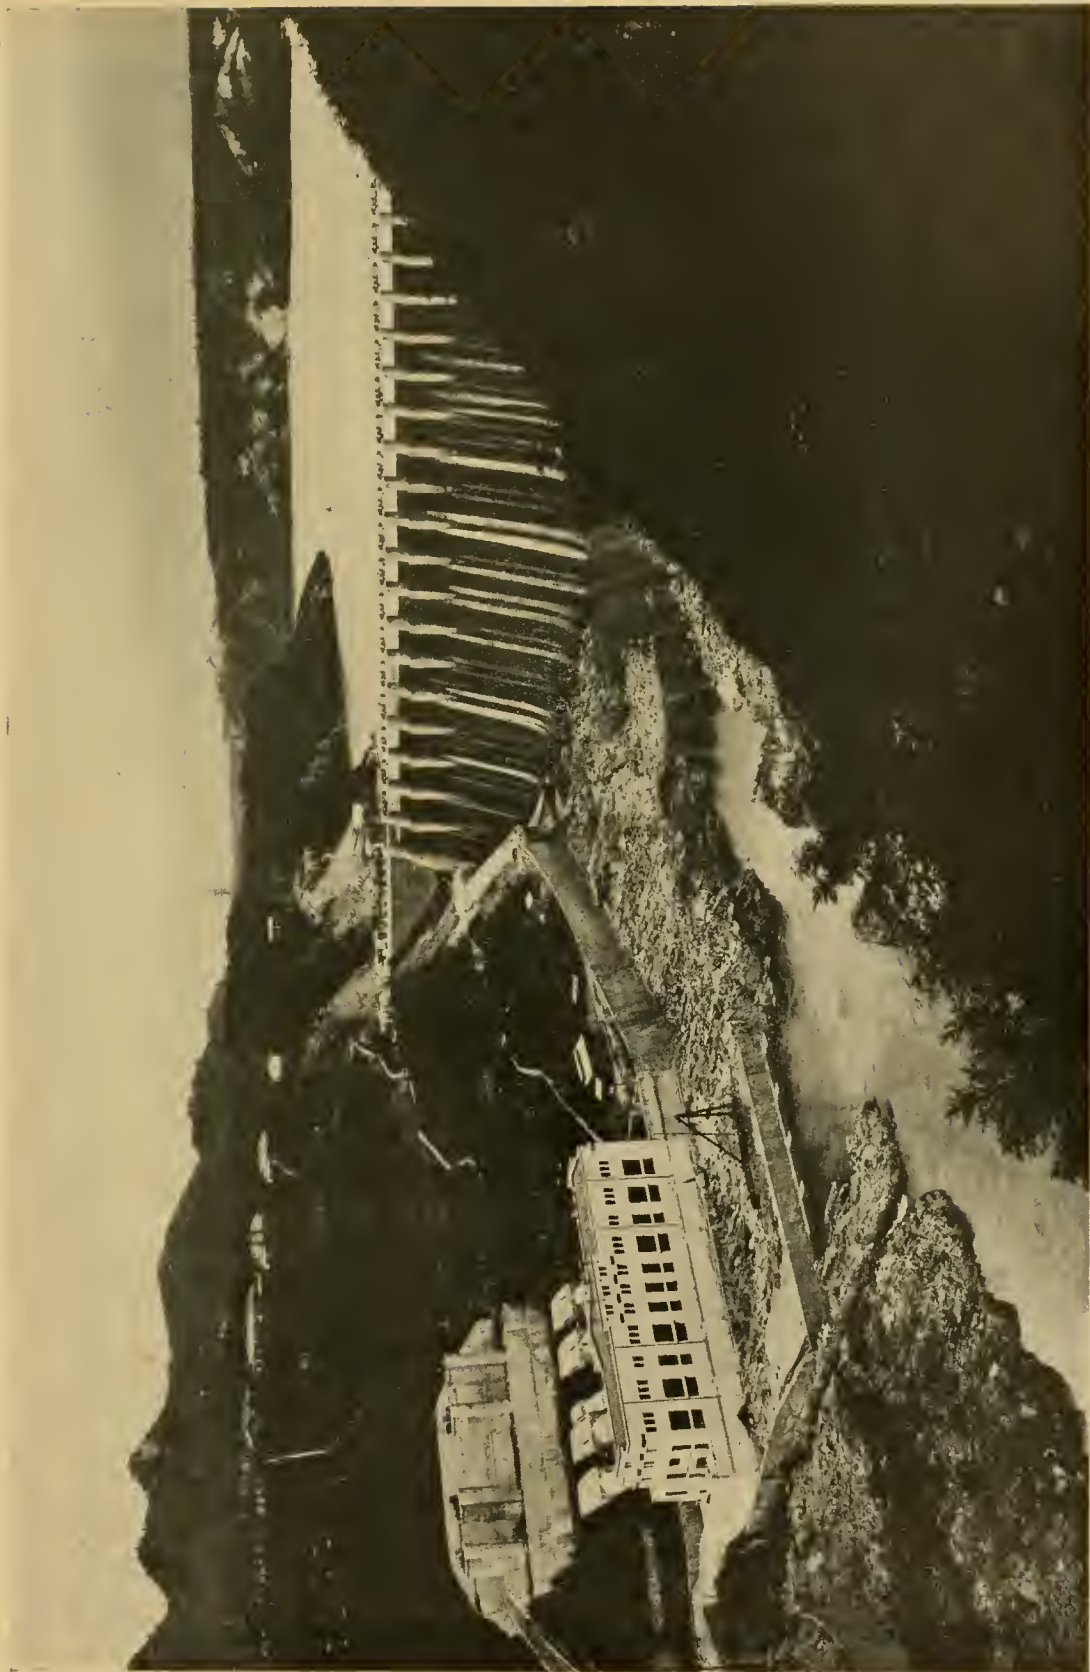
The Oi plant was completed in November 1924 and is the largest plant on the Kiso River (Exhibit C, photo 15). The dam is a concrete, overflow, gravity-type with 21 tainter gates and impounds approximately 250 million cu ft effective water storage, and approximately 400 million cu ft total storage. Water is brought to the plant through a pressure tunnel 1,020 ft in length to a surge tank and thence through 3 concealed penstocks, each 250 ft long. The effective head is 1,400 ft, and the water quantity used is 4,900 cu ft/sec. There are 4 Allis Chalmers, single-wheel, vertical turbines, each with a General Electric generator rated 13,750-KVA at 80 percent PF. This gives a total name plate rating of 44,000 KW; however, the maximum power obtainable is 48,000 KW, and the size of the plant is so rated. Adjacent to the plant, there are 3 banks of transformers, each consisting of three 9,200-KVA, 6.6/154-KV, single-phase transformers, of which one bank is spare. On a higher elevation located nearby is a switching station to which a connection is tapped to the 154-KV, Kiso line to Osaka and also is the starting point of the Kansai, 154-KV line to Osaka via Yao.

Photo 15—Oi power plant, general view

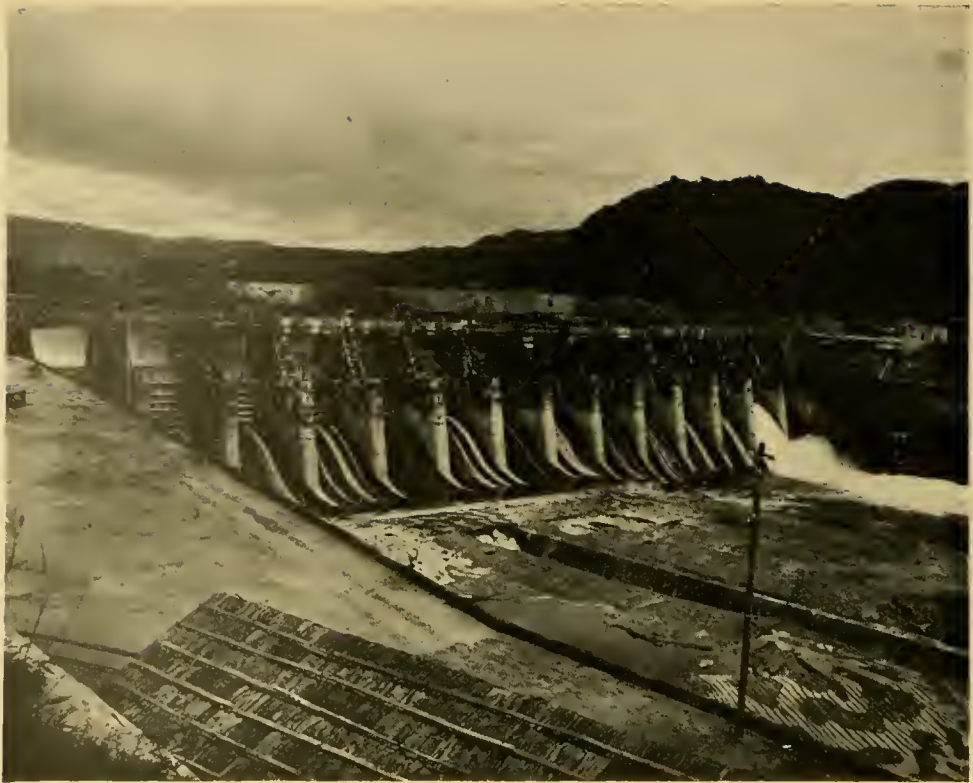
The Kaneyama plant was completed in March 1944. (Exhibit C, photo 17) Across the Kiso River is a concrete storage and diversion dam (Exhibit C, photo 16), approximately 600 ft in length, with 14 tainter gates. This dam stores approximately 280 million cu ft of water of which 94 million cu ft are classed as available. From a head race adjacent to this dam, there are 3 concealed steel-lined concrete tunnels or penstocks to the plant. In the plant are 3 Kaplan-type Mitsubishi-make turbines, each with a Mitsubishi generator with a name plate rating of 15,500 KVA at 80 percent PF. The total name plate rating of the plant is 37,200 KW; however, the rating given on the records is 37,100 KW. Adjacent to the plant is an outdoor transformer and switching station (Exhibit C, photo 18). There are three 15,500 KVA 3-phase 11/154-KV transformers and a tap to the Kansai transmission line to the Yao substation near Osaka.

Photo 16—Kaneyama power plant diversion and storage dam

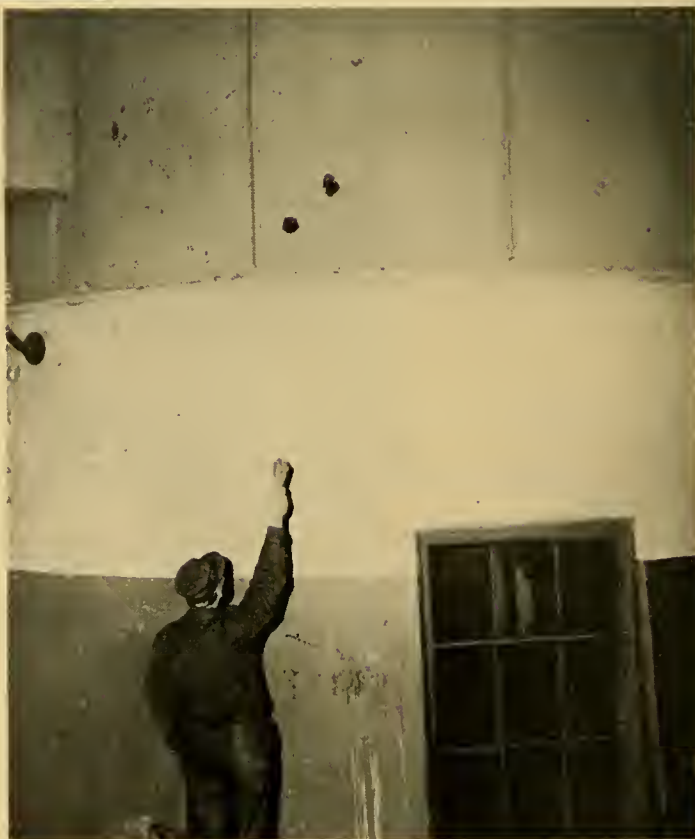
2. The plant was never a primary target, but was damaged on 30 July 1945 by carrier-based Navy planes unable to reach their planned objective. One 250 lb fragmentation bomb hit near the turbine room, damaging one generator and destroying a regional load dispatcher's office building, and 50-cal strafing punctured in several places the surge tank above the penstocks.

Photo 4—Bomb fragment holes in generator housing

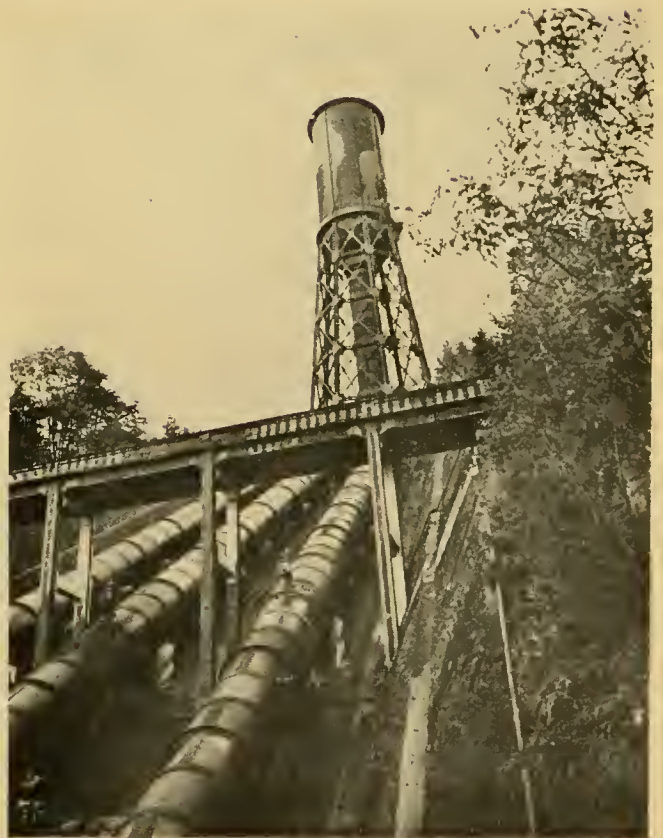
Photo 6—Tank (damaged by strafing) and penstocks

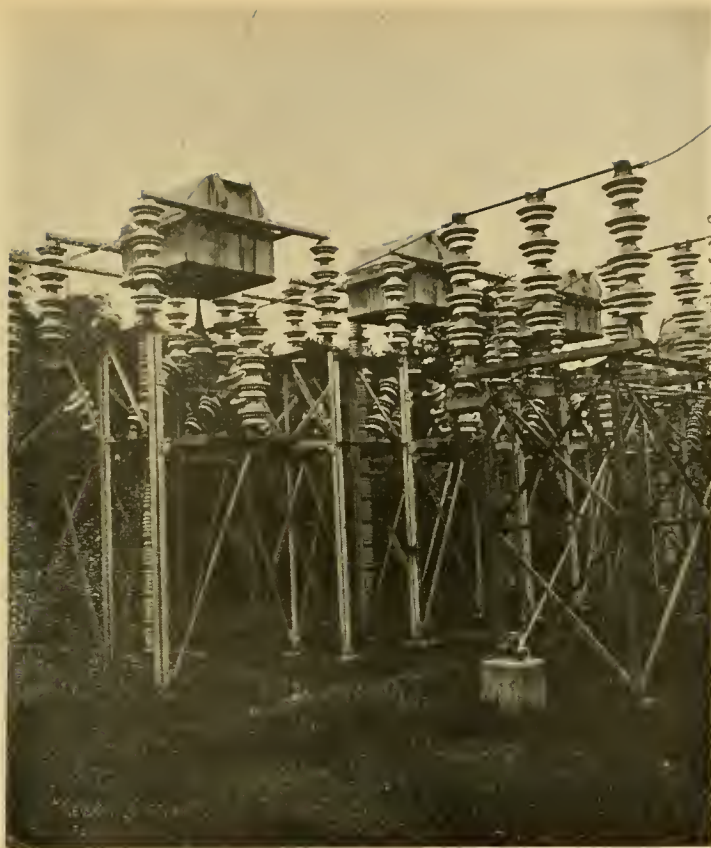
and a few 100-lb HE bombs on urban area of Nagoya and on 17 May 1945, 457 B-29 aircraft dropped 3,609 tons of IB on south urban area of Nagoya. These are evidently the raids on which the incendiary bombs fell on this station, but it was never a primary target. Blast barriers made of wood and sand had been placed around the transformer bank (Exhibit B, photo 13), but no other protection was provided and such vital equipment as the 154-KV oil circuit breakers (Exhibit B, photo 14), and other similar items (Exhibit B, photo 15) were totally unprotected.

Photo 15—Nisshin—Lightning arrestor installation

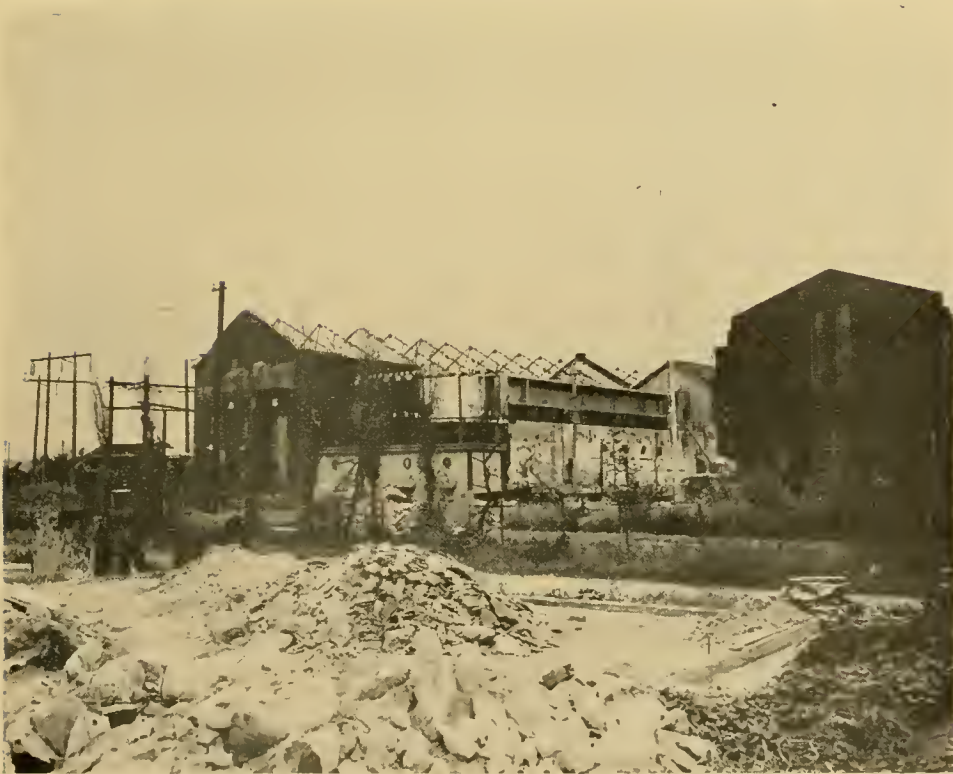
This station was never a primary target, but was severely damaged on 14 May 1945 during a raid on the north urban area of Nagoya when 411 B-29 aircraft dropped 2516 tons of IB. A large number (quantity unknown) fell on this station. The fire resulting from the burning of the combustible buildings on and adjacent to the station property completely destroyed the electrical store room (Exhibit B, photo 20), testing shop, numerous other miscellaneous buildings, and partially destroyed the office, switchroom (Exhibit B, photo 7), 11- and 77-KV, oil, circuit breaker

Photo 16—Rokugo—General view of damaged station

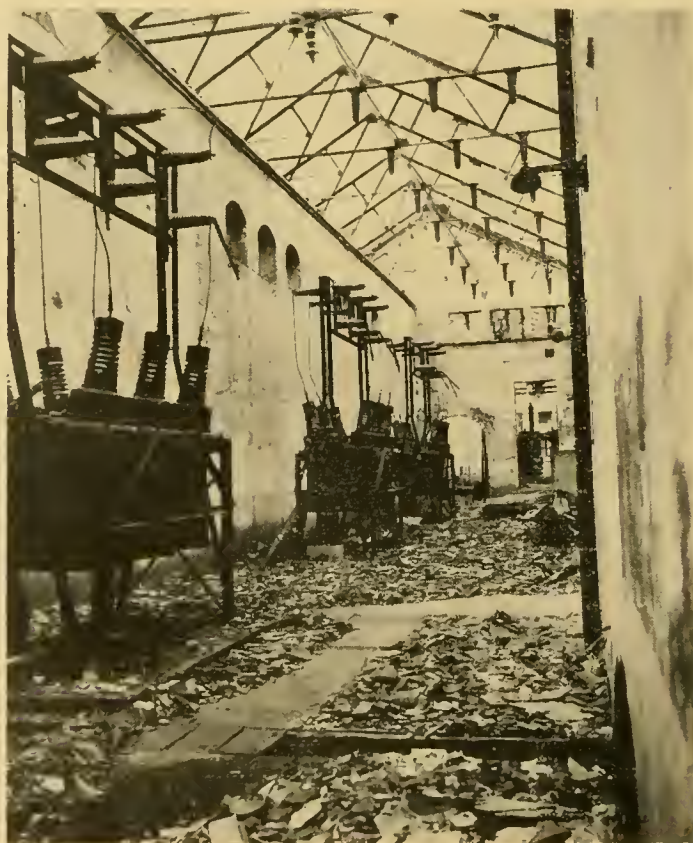
room (Exhibit B, photo 18), the transformer room housing the group of 2,500 KVA transformers, as well as the 10,000-KVA, 3-phase transformer located adjacent thereto. (Exhibit B, photo 19). All the oil circuit breakers, the control board (Exhibit B, photo 17), and the transformers were put completely out of service, and while minute examination has not been made, it is expected these are all completely ruined. The 10,000-KVA transformer will require a complete rebuilding. The three 4,000-KVA transformers were not damaged and were placed back in operation on 22 July 1945. This is the only portion (except the synchronous condenser) of the station that was not badly damaged. All the load sheets were destroyed by fire, but officials advised that the station was carrying a load of about 32,000 KVA, and, since restoration of the one remaining transformer bank, the load is from 2000 to 2300 KVA. No protective measures of any kind had been taken. Complete repairs to all equipment and buildings will require at least six months.

Photo 18—Rokugo—77-KV oil circuit breakers destroyed by fire

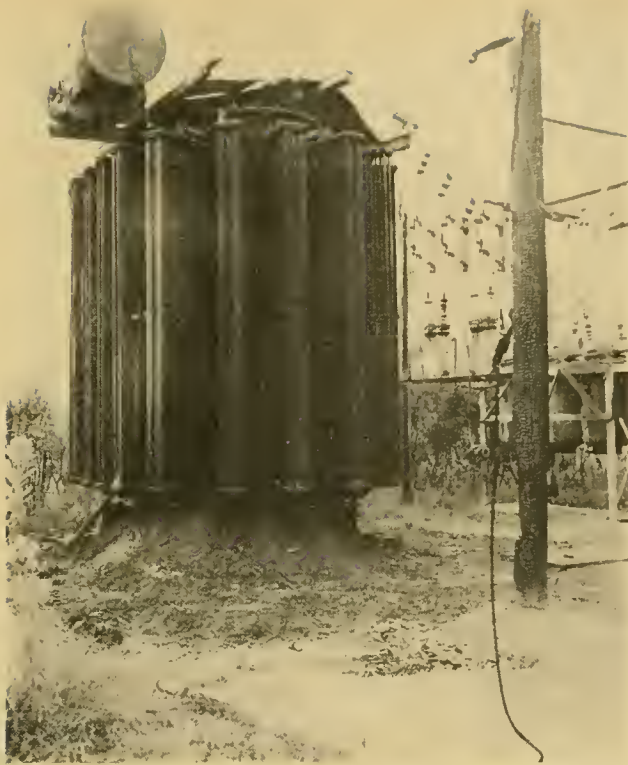
Photo 19—Rokugo—10,000-KVA 3-Phase transformer completely ruined by fire
